Manhole Inspection Summary

Manhole # S25CC1022MH

Location Address: **3747 HICKORY AVE**

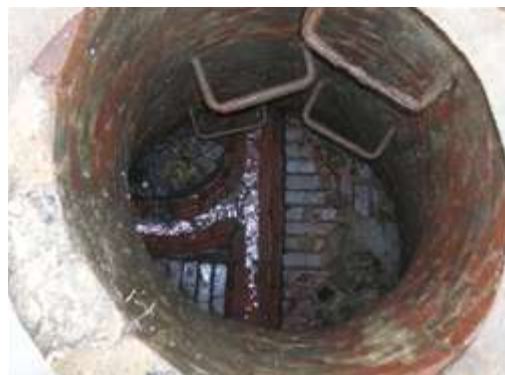
Top View

Corroded steps. Evidence of surcharge - Bench debris.

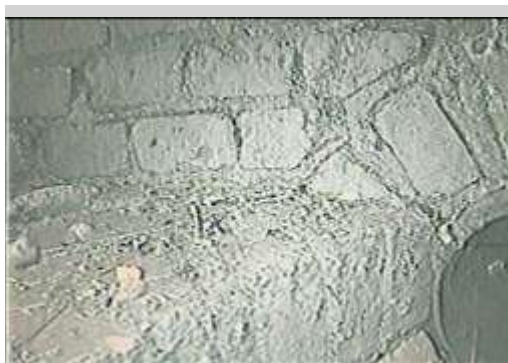
Defect

Barrel deterioration, root intrusion and infiltration.

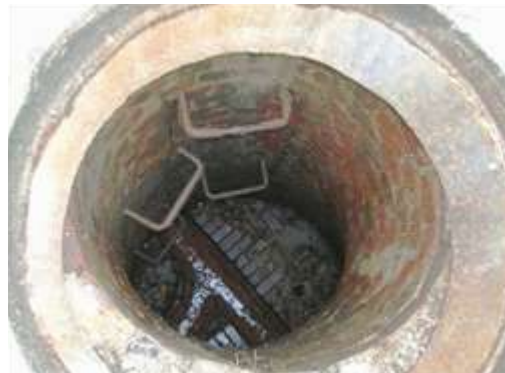
Defect

Frame leaks. Frame offset. Adjustment and Corbel root intrusion and infiltration.

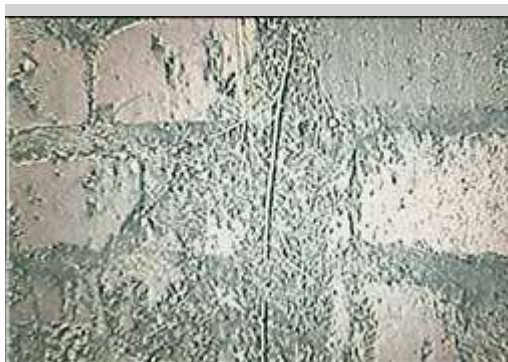
Defect

Barrel root intrusion and infiltration.

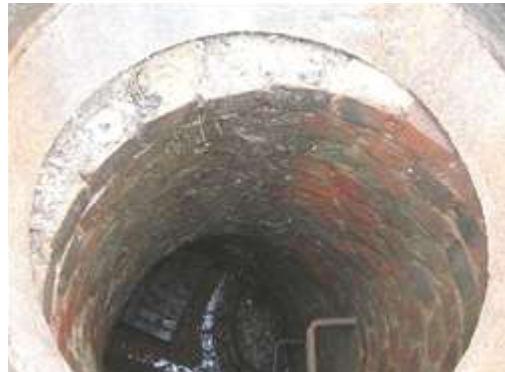
Defect

Frame leaks. Frame offset. Adjustment deterioration, root intrusion and infiltration.

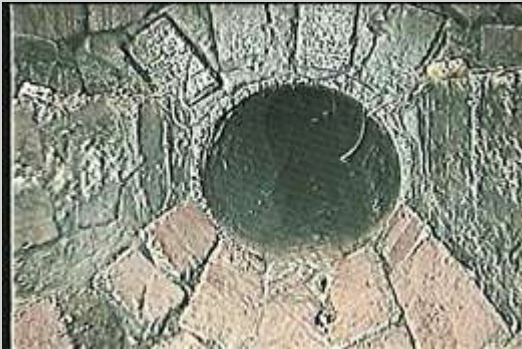
8 in. Circular Gravity Sewer Pipe Out @ 12 O'Clock

Barrel deterioration and infiltration. Channel deterioration.

Infiltration: **Evidence** Pipe Seal Cond: **Roots**

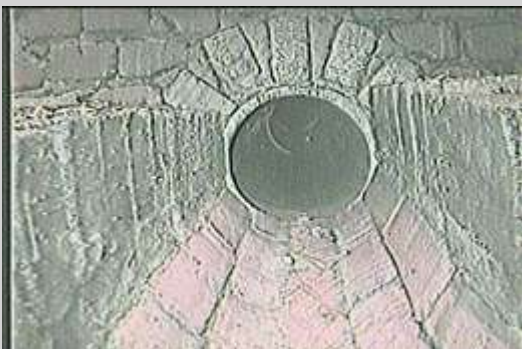
8 in. Circular Gravity Sewer Pipe In @ 6 O'Clock

Barrel deterioration and infiltration. Channel deterioration.

Infiltration: **Evidence** Pipe Seal Cond: **Unknown**

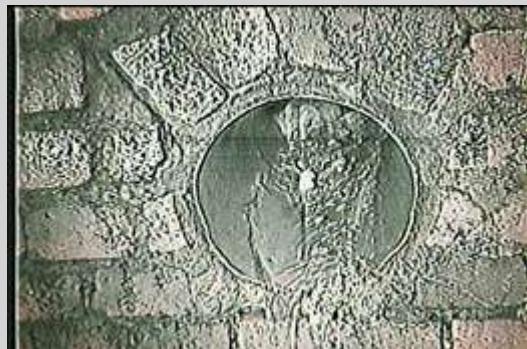
Pipe In @ 9 O'Clock

Infiltration: **Evidence**

Pipe Seal Cond: **Roots**

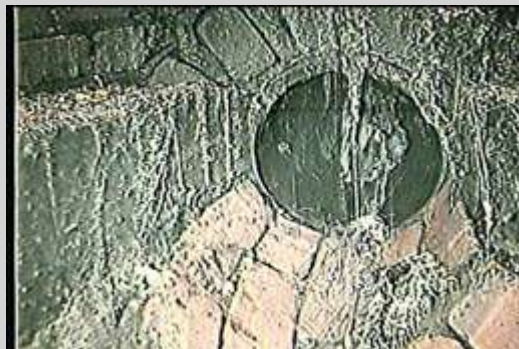
Drop In @ 9 O'Clock

Drop Condition: **Partly Clogged**
